Establishing a Diagnostic Technique for Identification of a Problematic Foundation

Abstract: — Diagnosis of a vibration problem when the machine has been assembled completely is often tedious. In fact there are several rotating components in a motor assembly which may be responsible for high amplitude of vibrations. In addition, any static component can also generate vibrations. When a rotating machine exhibit large vibrations, often the doubt goes to moving components or the bearings. Efforts are carried out to identify a problem in one of these components, but sometimes it may so happen that no fault is identified in rotating parts or bearings and still the vibrations become uncontrollable. This is exactly what happened in a motor in a Nuclear Power Station having 2 machines each of 236 MW rating. In place dynamic balancing was carried out but it did not help. Frequency analysis revealed some looseness in nuts and bolts but controlling them also could not reduce the vibrations. Ultimately, the recently developed technique of phase measurement and analysis was applied and the problem was diagnosed to be that of faulty foundation system. Appropriate corrections were then made and

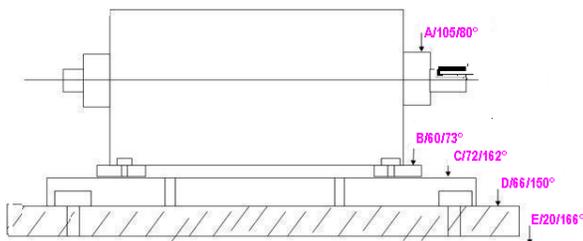
Fig. 1: Vibration & Phase Measurements before Making Corrections

It was observed that between the motor feet and base frame the readings are not consistent. At location B, the amplitude is 60 microns and phase is 73°. At location C, the amplitude should decrease and phase should remain same. But, the amplitude has increased to 72

microns and phase is 162° (changed by 109°). Refer Fig. 4.19. This particular type of behavior is not normal.

2.6: Investigations were made to pin point the cause of such behavior. The foundation was dismantled for making visual observations. It was observed that the motor feet were left un-machined. Also, the shims put between the motor feet and base frame were not proper. Many shims were placed one over another and a thickness of 0.12 mm was built-up.

2.7: For making improvements, the machine was dismantled, motor feet were machined and shimming was improved by placing only one plate of the required thickness. The machine was reassembled and run for observations.

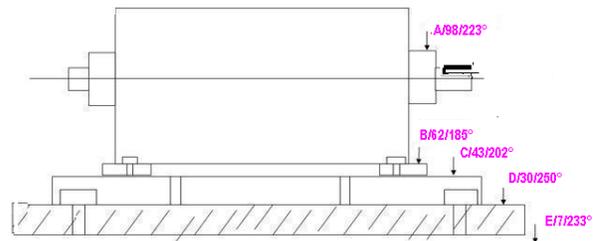
2.8: The motor was run at rated speed of 1000 RPM and observations were taken. Refer Fig. 2 and Table 1 for observations. It can be observed that the 2X RPM component was fully eliminated. Only 1X RPM component was present.

Fig. 2: Vibration & Phase Measurements after making corrections

2.9: The 1X component was easily balanced by placing 220 grams of weight on DE side fan and the vibrations were brought down to permissible levels.

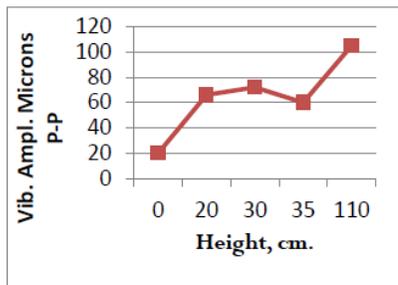
Fig.3: Variation of Vibration with Height during Initial run

It can be observed from these diagrams that the pattern of vibration from bottom to top was not as desired during initial run. However, after proper machining of the foundation this pattern has improved.

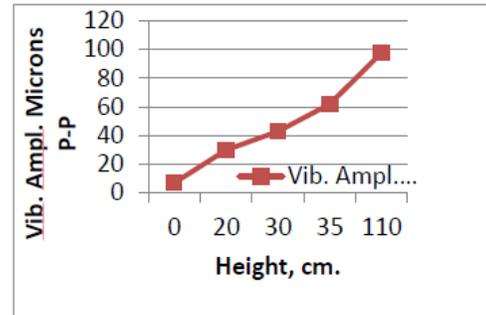
Fig.4: Variation of Vibration Amplitude after Final Corrections

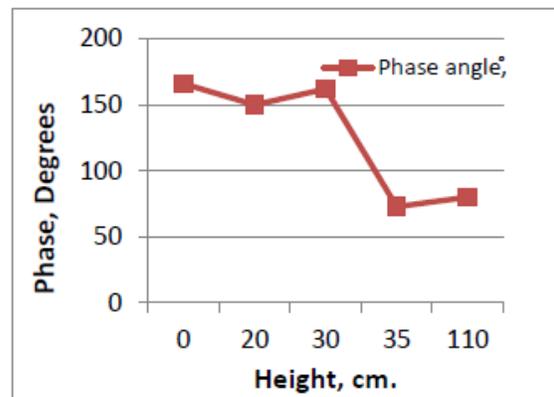
3.5 Variation of phase angles in degrees with respect to height during initial and final runs is presented in Fig. 5 and Fig. 6. It can be observed from these diagrams that the pattern of phase angles from bottom to top was not as desired during initial run. However, after improving foundation by machining etc. this pattern has improved.

Fig. 5: Variation of Phase Angle with Height during Initial Run

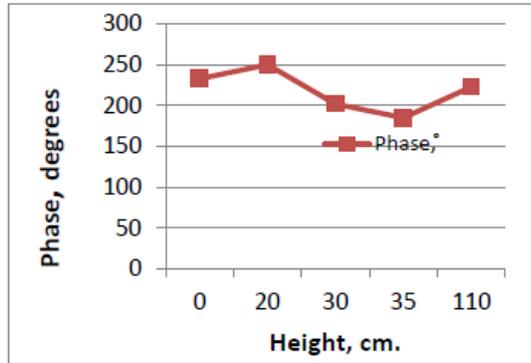
Fig. 6: Variation of Phase Angle with Height after Final Corrections

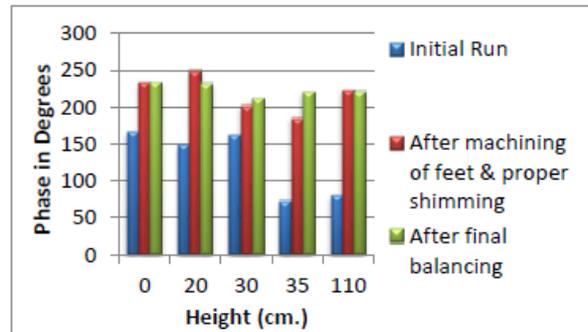
Fig 8: Phase Angles at Various Heights under Different Operating Conditions

3.6 Vibration amplitude and phase angles at various heights under different operating conditions are shown in Fig. 7 and Fig. 8 respectively. It can be observed that there is improvement in trend after correcting foundation and conducting final balancing.

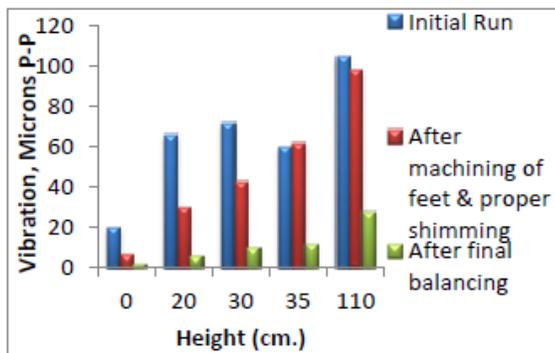
Fig. 7: Vibration Amplitude at Various Heights under Different Operating conditions
