# Effects of 2015 Gorkha Earthquake on Residential Buildings in Bhaktapur Municipality, Nepal

<sup>[1]</sup> Manoj Bakhunchhe Shrestha, <sup>[2]</sup> Tulshi Laxmi Suwal

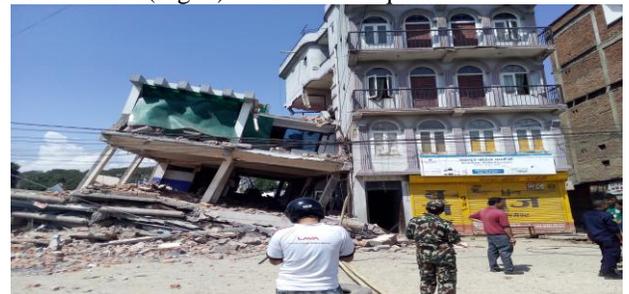
**Fig. 2. Collapsed RC Frame Buildings at Bhaktapur -17 due to aftershock on 12th May 2015**

earthquake safety provisions which results in lesser percentage of damages in RC frame than other structures. Fig. 2 and Fig. 11 shows the sever damages on RC frame structures mainly due to non-engineered design and lack of technical supervision and monitoring during construction phase.

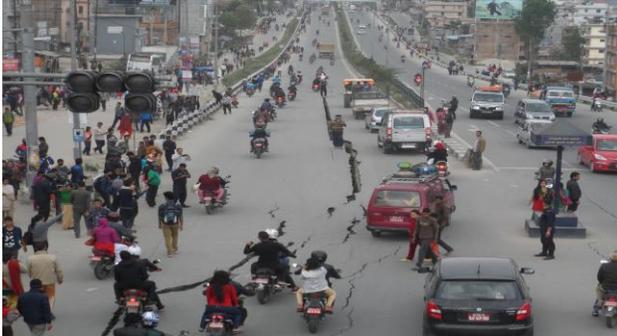
**Fig. 3. Damaged road at Kausaltar, Bhaktapur**

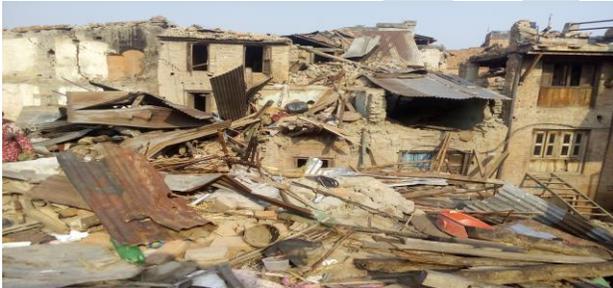
The overall result shows that building typology of Adobe plus Mud joint had exhibited more damage characteristics than the other building typology. Adobe plus Mud joint buildings have mud mortars which has weak bonding nature than other mortar. The seismic resilient capacity of this type of structures is low due to lack of integrity of structural components, the strengths of the wall and the lack of elements tying the structural component. The main reasons for damages in the study area were due to age of the buildings and non-engineered traditional building typology. Other reasons for huge destructions on Adobe plus Mud joint building typology were due to lack of joist, ties and latches in different parts of buildings, and also those buildings which had generally four to six stories (Fig. 7). For the Adobe plus Mud joint buildings, the increase in stories is proportional to the risk of damages due to the earthquake. Another reason was due to unsymmetrical nature of buildings for more damages. No proper maintenance and pre-retrofit of such buildings were done to minimize the losses due to the earthquake disaster. The face of buildings which were not in plumb and were easily visible with naked eyes could easily be spotted in the municipal areas before earthquake and still. It was also revealed that poor workmanship might be the one of the causes of damages. Some of such buildings foundation depths were found with just 1-2 feet which is inadequate to resist axial load as well as dynamic load during earthquake as revealed on the focused group discussion. The thicknesses of

upper walls were comparatively found to be less than those of ground floors which were seen more damaged in the locality. Another reason for the cause of more damage, i.e. full open spaces in upper stories with no partition walls, only the boundary skin walls on the periphery. In addition, the topography of the locality also played the role to increase in the damages of the buildings in certain area like Sano Byasi and Golmadhi in comparison to other locality due to its sloppy terrain topography. The more damages were also because of the more dampness on that locality which made weaker the structure due to course in Adobe and Cemented Load bearings wall buildings. As from FGD in ward number 1, the damaged buildings by earthquake in 1934 were renovated and constructed only from above the foundation, which was also the main cause of more destruction. Some parts of ward number 16 also lies in sloppy area where the extensive damage can be witnessed. Despite the huge damage in mud mortar buildings the World Heritage Nyatapolan (five story roof) temple had experienced very less damage. Only some bricks were spilled out at the fifth floor. The low damage of the Naytapolan (Fig. 8) is mainly due to its flexibility behavior of timber, workmanship and of course the center of gravity (CG) of the structure also.

**Fig. 7. Damages seen at Jellan, Bhaktapur.**

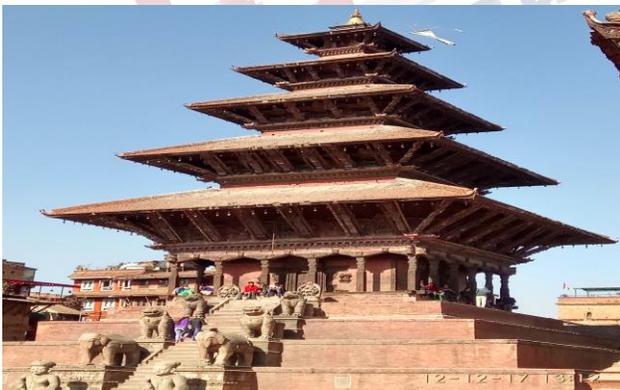
**Fig. 8. Minor Damages in the World Heritage, Naytapolan.**

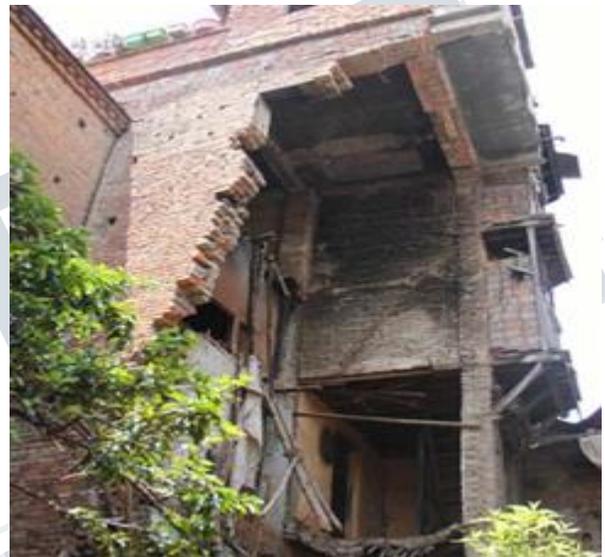
Adobe plus Brick in cement does not behave uniformly on seismic activity because of partially behaving non-rigid on below part and behaving partial rigid behavior in upper parts treating as complex in nature. These types of non-engineered modification cause irregularities in elevation which adversely limits the structural performance to axial loadings and the maximum stresses are induced in ground floor having mud mortar and obviously, they cannot bear the stresses (Fig. 9). This type of construction generally done by the house owners when their income rises, later on, due in the course, even some house owner made rigid floors and roofs too.

**Fig. 9. Hanging Non Engineered Modification house (Source: BM).**

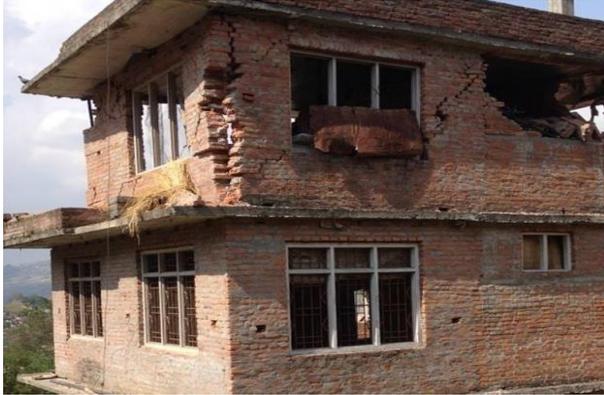
It was seen that the damage grade was seen lesser than that of Adobe plus Mud joint and Adobe plus Brick in cement (Fig. 10). Most of this typology had rigid floor with rigid roof. And with no doubt, these buildings bonding capacity which uses burnt brick is much higher than mud mortar. The burnt brick strength is obviously much more than Adobe sun-dried bricks. Mostly those buildings have also RC beams which intact the whole structure in different levels. The structural performances were also not purely adequate on this typology. In the study area, these typologies were not old in age as compared to mud mortar buildings.

**Fig. 10. Damaged Brick in Cement building.**

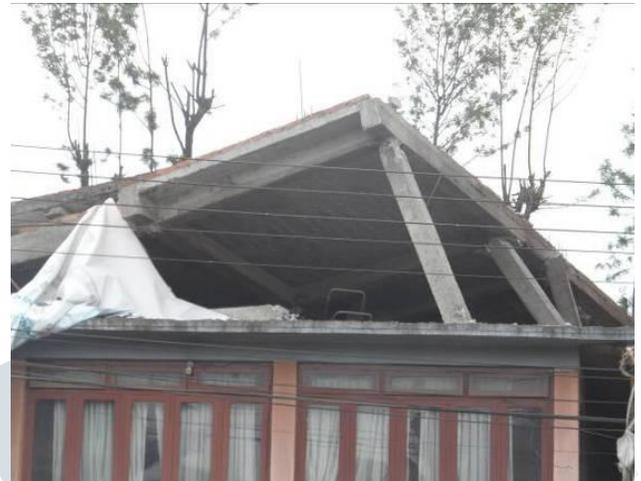
**Fig. 11. RC frame 2nd floor collapsed at Jagati, Bhaktapur.**
