Infrared Thermography for Building Inspection: A Non-Destructive Method

III. AREA OF STUDY

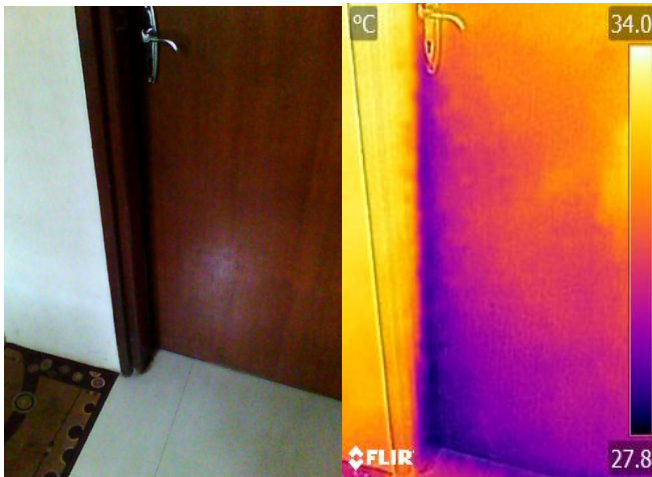
Fig (h): Air leakage through Meeting room

In fig (h) the air leakage of the door has shown even though the door is closed the cool air is leaking between the door and the casing.

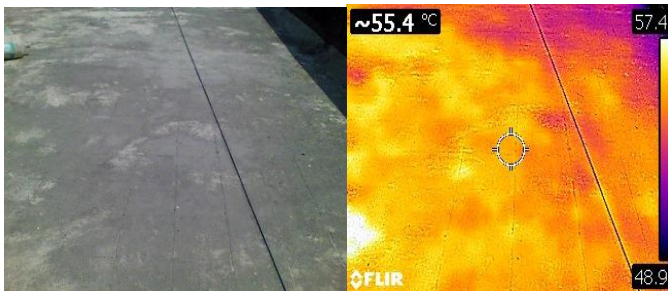
Fig (i): Roof Top at Civil Building

In fig (i) the roof top moisture can be seen in pink color. This thermography is called as active

thermography because the source of heat i.e., the sun is heating the subject uniformly.

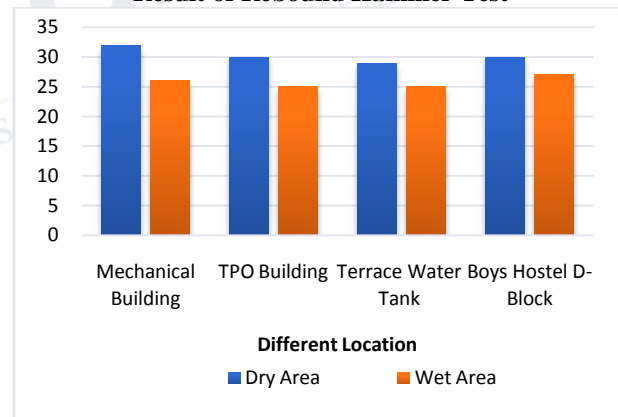
Result of Rebound Hammer Test

The last step is to cross check with the rebound hammer. The following table shows that the reading collected on site testing using rebound hammer testing. The following bar chart shows the reading collected on site testing using rebound hammer testing. Y-axis shows the Rebound Hammer Number. The strength of concrete on dry area is 32 N/mm² while on wet area, it's strength comes to 26 N/mm² in case of Mechanical Building, which shows that the strength comes more on dry area rather than wet area. The rebound value was come to be lesser when the test performed on the wet area because the strength gets considerably reduces when the wall become wet. On several areas, the test was conducted to make sure that the result obtained from the thermal camera was absolute.

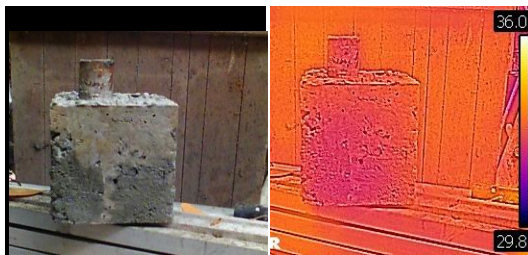
Fig (j): Before pouring the water in the block

As seen from the figure (k), the source of leakage can be easily detected. The dark blue portion shows the accumulation of water in the concrete block. For experiment purpose, the water was poured in the pipe which is in the concrete block and kept for some time. Fig (j) is the thermogram prior to pouring the water. As we can see in the normal photo it was hard to predict the exact location of leakage but in thermogram, the dark violet shows the most accumulation of water which is ultimately the source of leakage.
