# Evaluation of Pollutants and Determination of Contaminants in the Bellandur Lake, Bengaluru

**Index Terms—** Eutrophication, Bellandur Lake, Physio-Chemical Analysis, Water pollution, Urbanization.

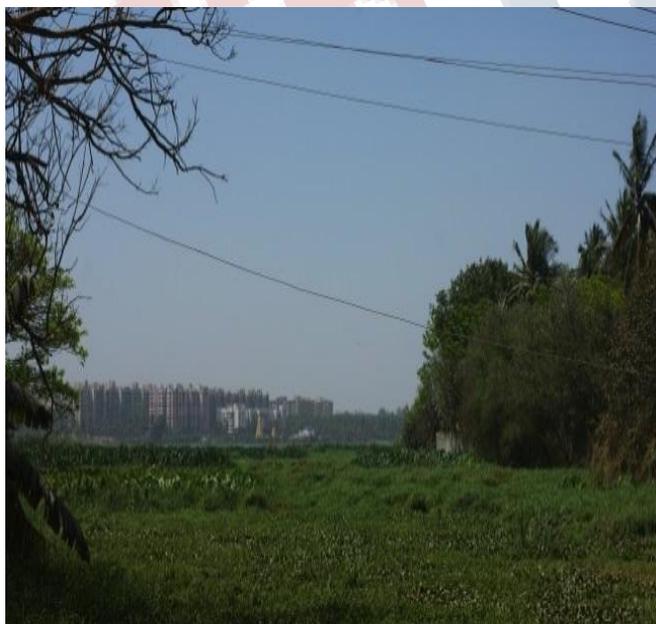
***Fig1: Eutrophication of the Bellandur Lake***

The most crucial effect of eutrophication is the formation of dense blooms of algae which causes reduction in water clarity and harms the water quality due to limited light penetration. This causes accelerated rates of photosynthesis which causes elevated pH values which blinds the marine life. The dense algae blooms eventually die and under decomposition which severely decreases the dissolved oxygen thus creating the dead zones that lack sufficient oxygen to support organisms. The abundance of organic substances gives the water disagreeable odours or taste and prevents the natural purification process. The toxic algae will also cause in the dead of animal and may pose a threat to humans. Due to the high concentration of the organisms there is a high degree of competition which causes physical stress and struggle for survival in eutrophic system. Increases nutrients levels may also stimulate other forms of macrophyte growth in addition to algae and cyanobacteria. From a purely aesthetic point of view excessive growth of macroscopic plants reduces the value of water body as a recreational resource.

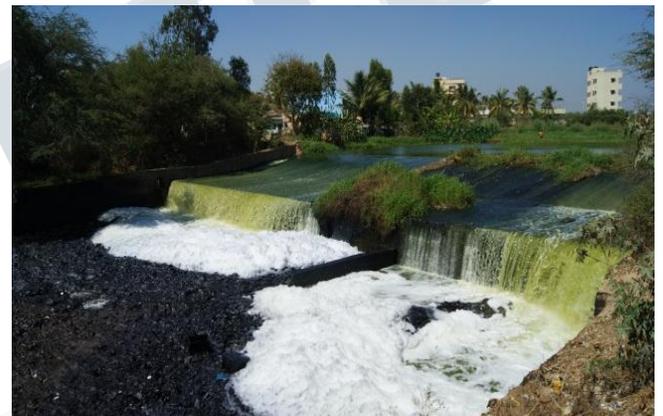
**Fig3: Outlets of Bellandur Lake.**
