# Effects of 2015 Gorkha Earthquake on Residential Buildings in Bhaktapur Municipality, Nepal

<sup>[1]</sup> Manoj Bakhunchhe Shrestha, <sup>[2]</sup> Tulshi Laxmi Suwal

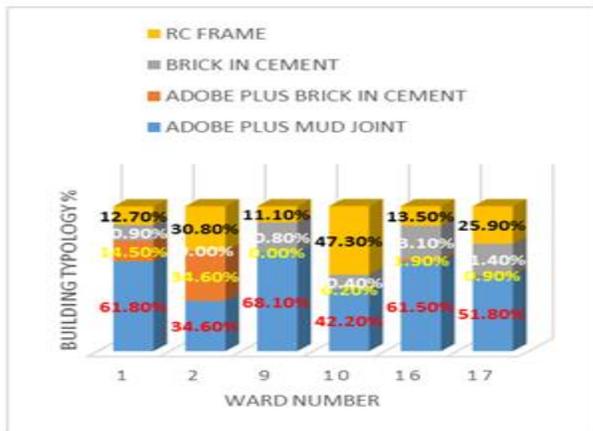
**Fig. 6. Building typology in different wards**

The majority structures were of Adobe plus mud mortar joint type in almost all wards which were more vulnerable to earthquake. Non-engineered modification of Adobe type, i.e. Adobe plus Brick in Cement structures were also found relatively. Brick in cement typology were also found in a well manner, whereas earthquake resistant RC frame structures were seen lesser in aggregate (Figure 6).
