Analysis and Reduction of surface defects in cars

Abstract – Cars are manufactured in various stages and stations and the occurrence of defects is inevitable. The aim of this project is to reduce the commonly occurring secondary defects in cars which are dent, scratch and peak. These defects are the most occurring ones that play a major role in the production decline. It is learnt that the secondary damages like scratch, dent, peak, multi-dent, inner peak, are the major reasons for the production decline. It is found that, in order to rectify and eliminate the defects, about 4 hours is required. If we concentrate on the defective cars then it will affect the production of the remaining cars. Eventually, this stymies the production and results in unwanted losses. On observing for many days, it's seen that the secondary damage "scratch" occurs repeatedly in fenders and this seems to be an intimidating problem. Hence, we have suggested a suitable protective material "Acrylic Fiber" which prevents any further damage.

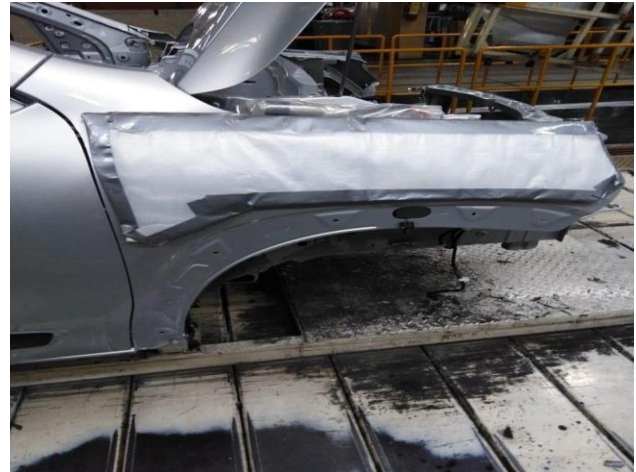
Scratches widely occur in the fender portion of the cars, so in order to prevent them we suggested a protective material to cover the fender during the operations.

The material is Acrylic Fiber or Synthetic fiber made from Polyacrylonitrile. The reason behind choosing this material is due to its advantage that it is resistant to wrinkling. It can also be wet or dry spun.

We use two layers of this material on the top and bottom and the material used betwixt these layers is Foam Rubber or Cellular sponge.

The thickness of Acrylic Fiber is 2-3mm both in the top and bottom layer while that of Foam Rubber is 5mm.

The main advantage of Foam Rubber is the reason behind its use here. It is manufactured with a foaming agent in order to create a air-centered matrix structure. And that acts a cushion thus preventing the damages to the fender.
